# KLAXON

*Restoration starts on Great Grandfather's  
1928 Morris Cowley*

### ***Restoration of 1928 Morris Cowley: Story by Bill Heard***

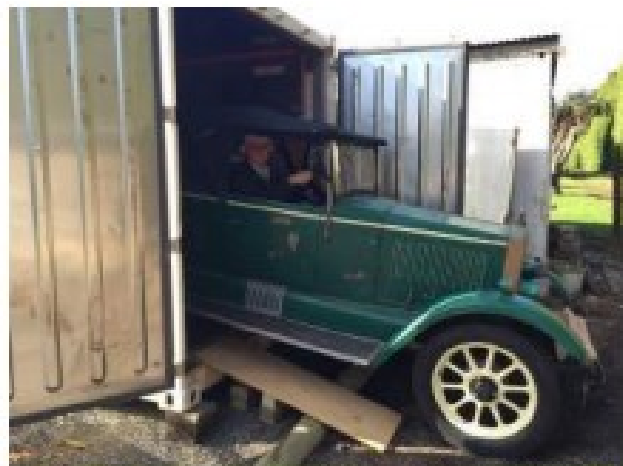
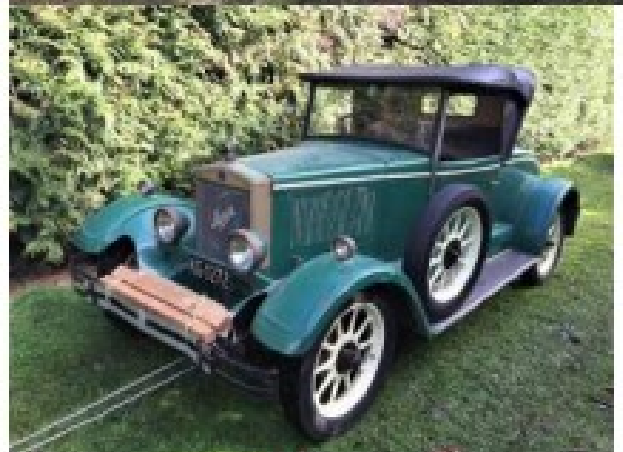
From there the project began. My brother and I started work in March 2019 on the car (known to the family as The Grasshopper) the job becoming first a case of dismantling, water blasting and removing component parts for an individual check

then repairing where necessary. At this stage I wish to point out that a camera is most necessary and used frequently. In some cases it may be a while before you are refitting some components again and a good record is essential.

I first of all removed and carted all of the mud guards around to the front lawn and set the job up for water blasting. Then removed the parking lights & the stiffeners inside the front guards. The stiffeners which reinforce the front guards, are very big, & people lean on them when servicing the engine. A section of the running board had been repaired many years ago. This area and both front guards are rusted quite badly, along with a patch where the stiffener is bolted to the guard.

With all the bolts and bits removed, I cranked the water blaster up and with 90+ pressure, years of dirt and grit departed to the lawn. Random other small panels including the spare tyre bracket were included in the wash down.
